FUNCTIONAL EVALUATION OF PATHOLOGIES IN FLEXIBLE PAVEMENT

ORIGINAL ARTICLE

NASCIMENTO, Jéssica Wanderley Souza do. Et al. **Functional evaluation of pathologies in flexible pavement.** Revista Científica Multidisciplinar Núcleo do Conhecimento. Year 06, Ed. 06, Vol. 01, pp. 110-129. June 2021. ISSN:2448-0959, Access link in: <https://www.nucleodoconhecimento.com.br/civil-engineering/flexible-pavement>, DOI: 10.32749/nucleodoconhecimento.com.br/civil-engineering/flexible-pavement

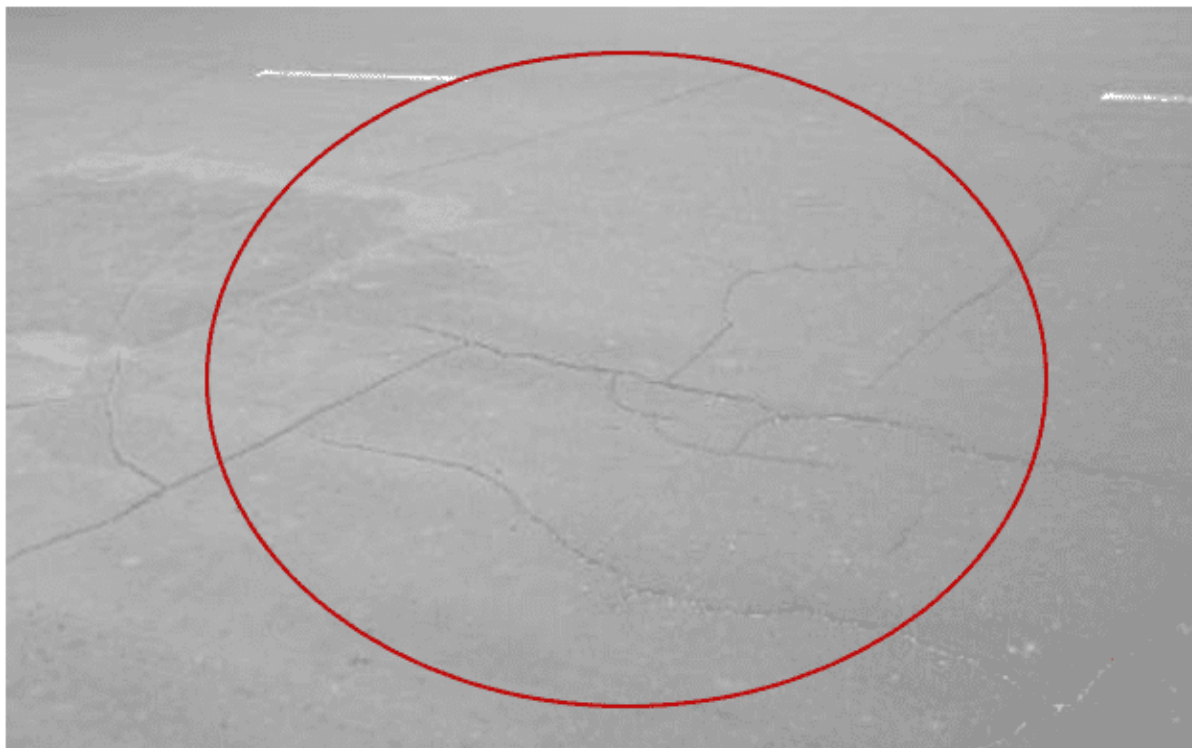
In the sections under study, cracks were observed: a) longitudinal; b) transverse; c) block cracking, according to Figure 2; and d) "leather-of-jacaré" (Figure 3). Applying this situation, the main reasons for the defects are: a) inadequate bonding between sidewalk layers; b) and c) shrinkage due to the region's high temperature; d) in addition to asphalt layer contraction due to high temperature, repeated deformations caused by heavy traffic and insufficient sidewalk thickness should be considered. All the cracks mentioned above were detected along the evaluated sections, varying only in severity.

Figure 2 - Block crack - Rodrigo Otávio Avenue (ZS).

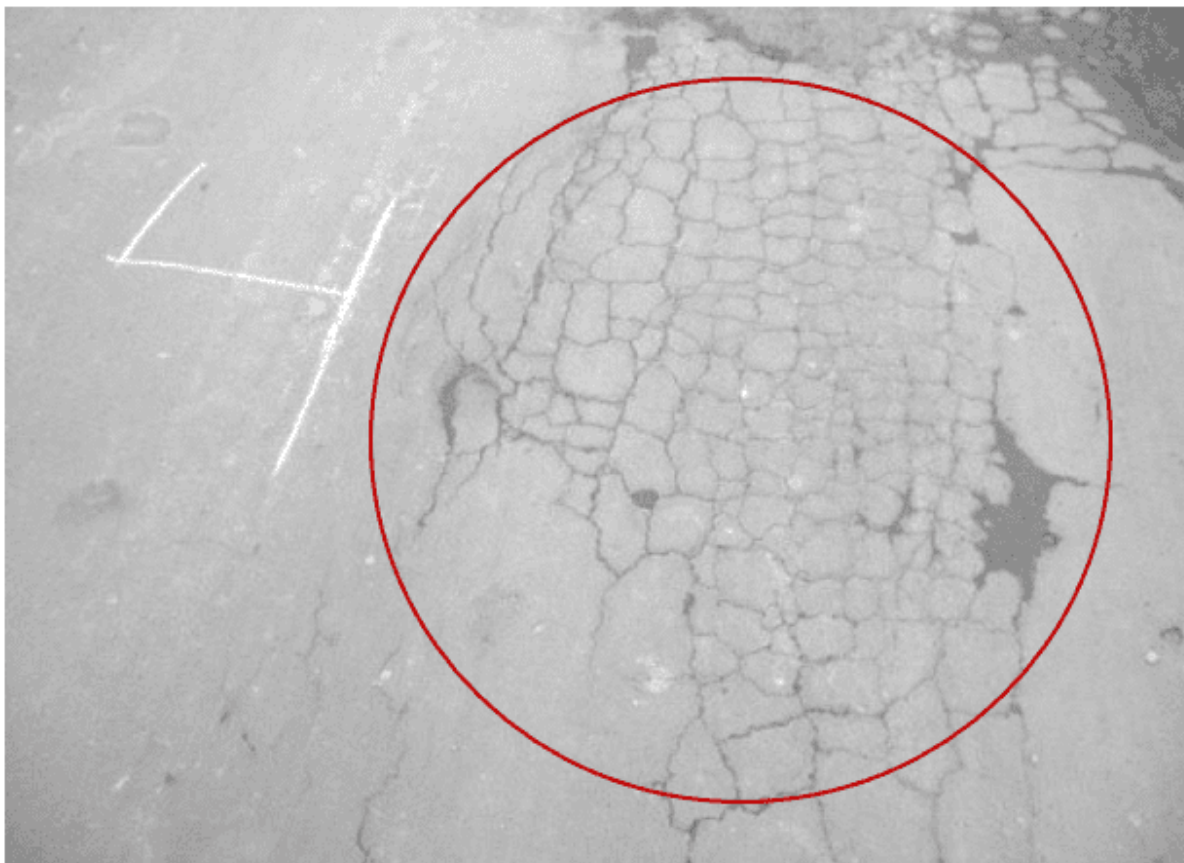
Figure 3 - Trincas couro-de-jacaré - Praia do Futuro Street (ZS).

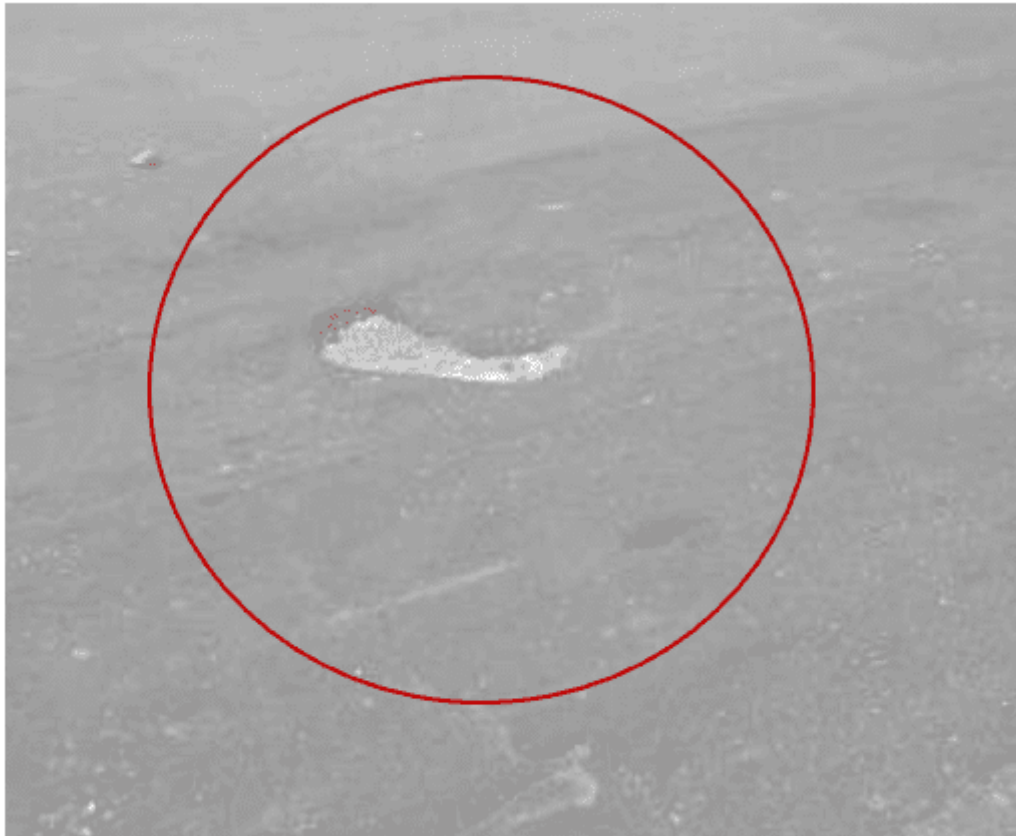
Patches represent the portion of the sidewalk surface larger than 0.1m² removed and replaced after initial construction. As with the evaluation of the severity level, the way to execute this pathology also depends on the type of defect presented, as described in the reference. This pathology was observed in several stretches of Avenida General Rodrigo Otávio, in both directions of traffic, as well as in the evaluated streets in the Tarumã neighborhood. The possible cause of this deterioration, incident in the stretches under study, is the slipping of the asphalt mixture after poor patching and errors in the dosage of the asphalt mixture, aggravated by increased temperature and excessive load, as shown in Figure 4.

Figure 4 - Patch with asphalt mix slip, with pan (ZS).

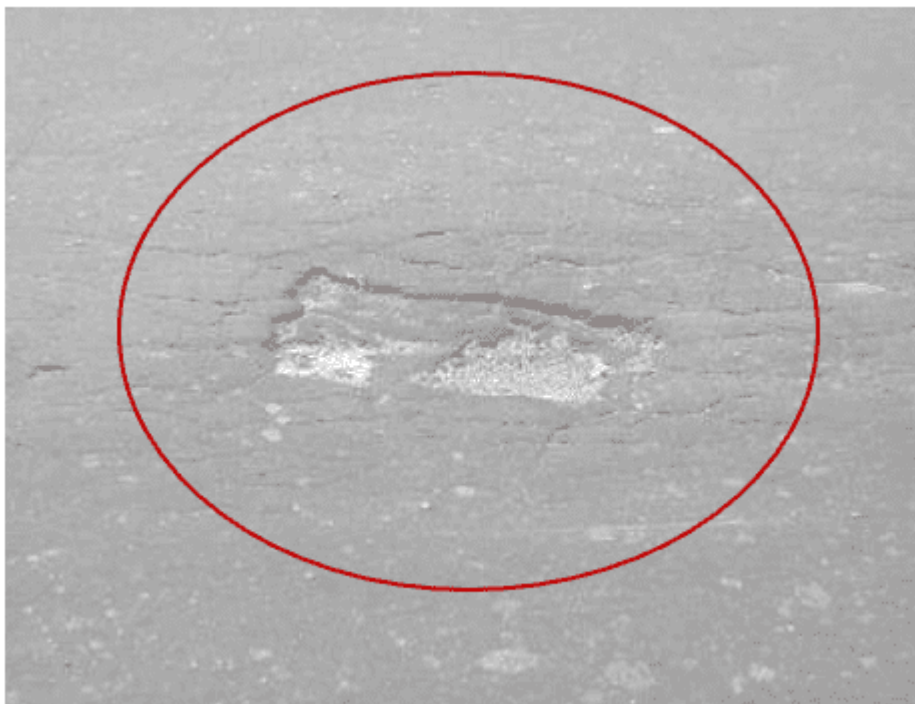
Figure 5 - Pans in cracks of the "alligator leather" type (ZS).

Several pans of varying magnitudes were found along the ZS stretch. At Av. Rodrigo Otávio, it became difficult to perform measurements of the dimensions due to the large flow of vehicles. According to the Manual of Evaluation, Maintenance and Restoration of Pavements of Urban Roads Rodrigues et al, there are several causes of these pathologies, among the significant number of this defect found on the aforementioned avenue of Manauense, the potholes with higher severity levels are shown in Figure 5.

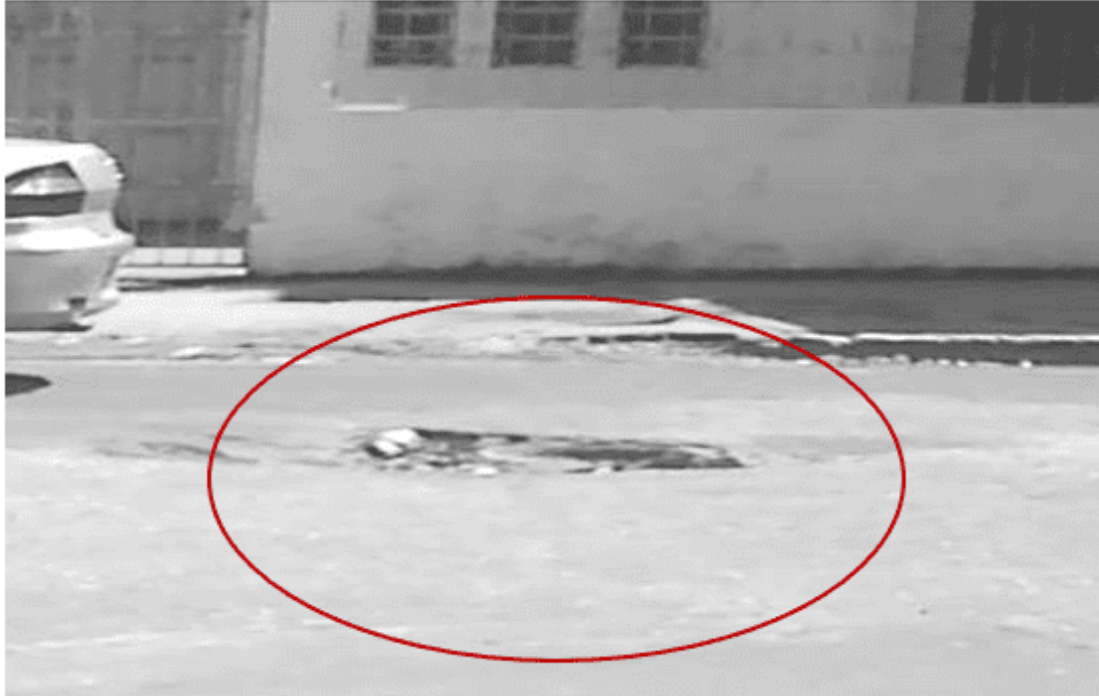
In Figure 6, it can be seen that the genesis of this problem is possibly the fatigue of the coating, while Figure 7, shows a structural defect in the underlying layer, since this pathology was deep and could easily be seen in the base of the sidewalk.

Figure 7 - Deep pan (ZS).

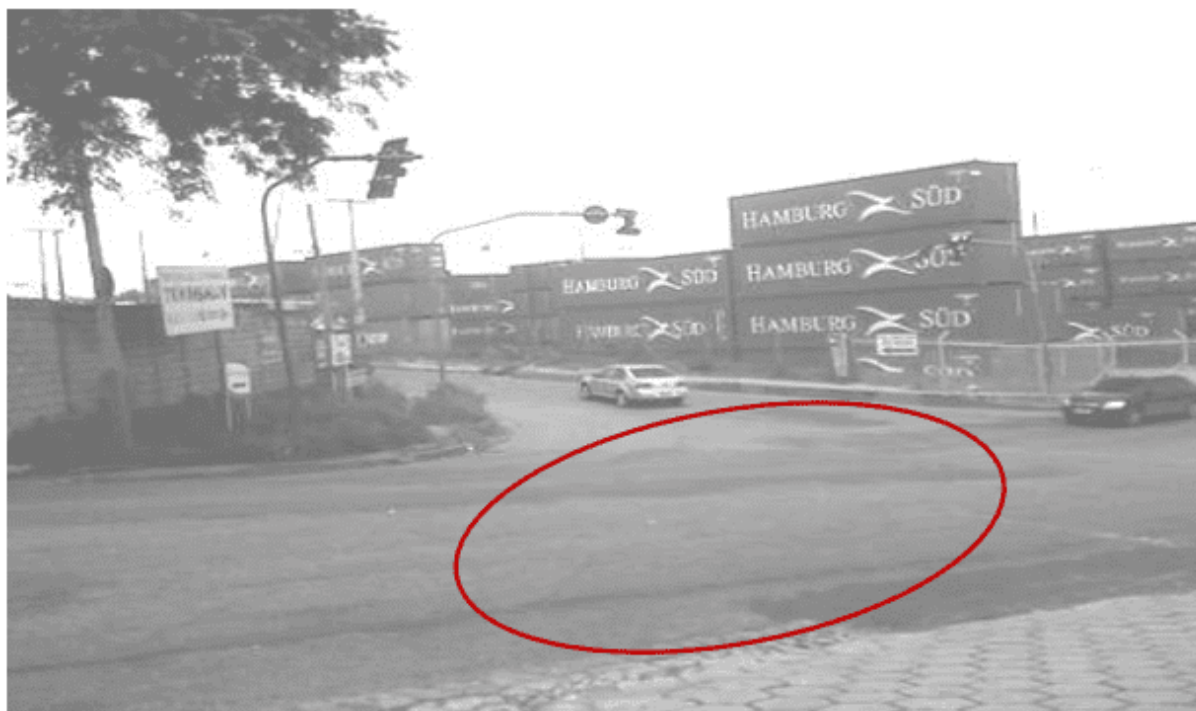
Figure 8 - Loosening of aggregate (ZS).

As for the pathologies related to surface defects, based on the references, rutting of wheel tracks, aging of asphalt mixtures, loosening of aggregate from the mixture, slipping of the coating, failures in the entrance and exit areas of the projects, and lack of adherence between the asphalt and the cobblestone surface were found. It was found that the pathologies such as loosening of the aggregate from the mixture, as shown in Figure 8, wheel tracks and slipping of the coating (Figure 9), are concentrated in certain stretches, while the aging of the mixture is found along the entire stretch where the potholing operation was not performed.

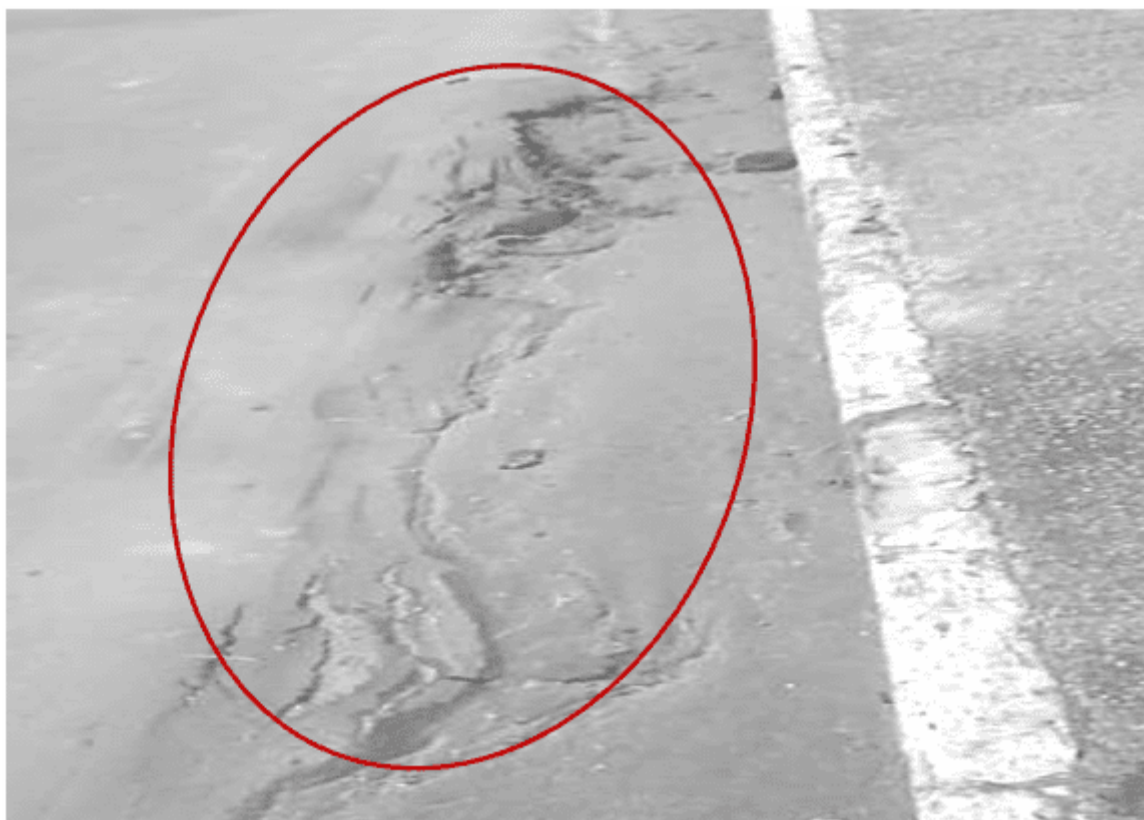
Figure 9 - Slippage (ZS).
